Texas Commission on Environmental Quality Investigation Report

**WILLIAMS BARNETT GATHERING SYSTEM LP
CN602903742**

WILSON COMPRESSOR STATION

Investigation # 795994

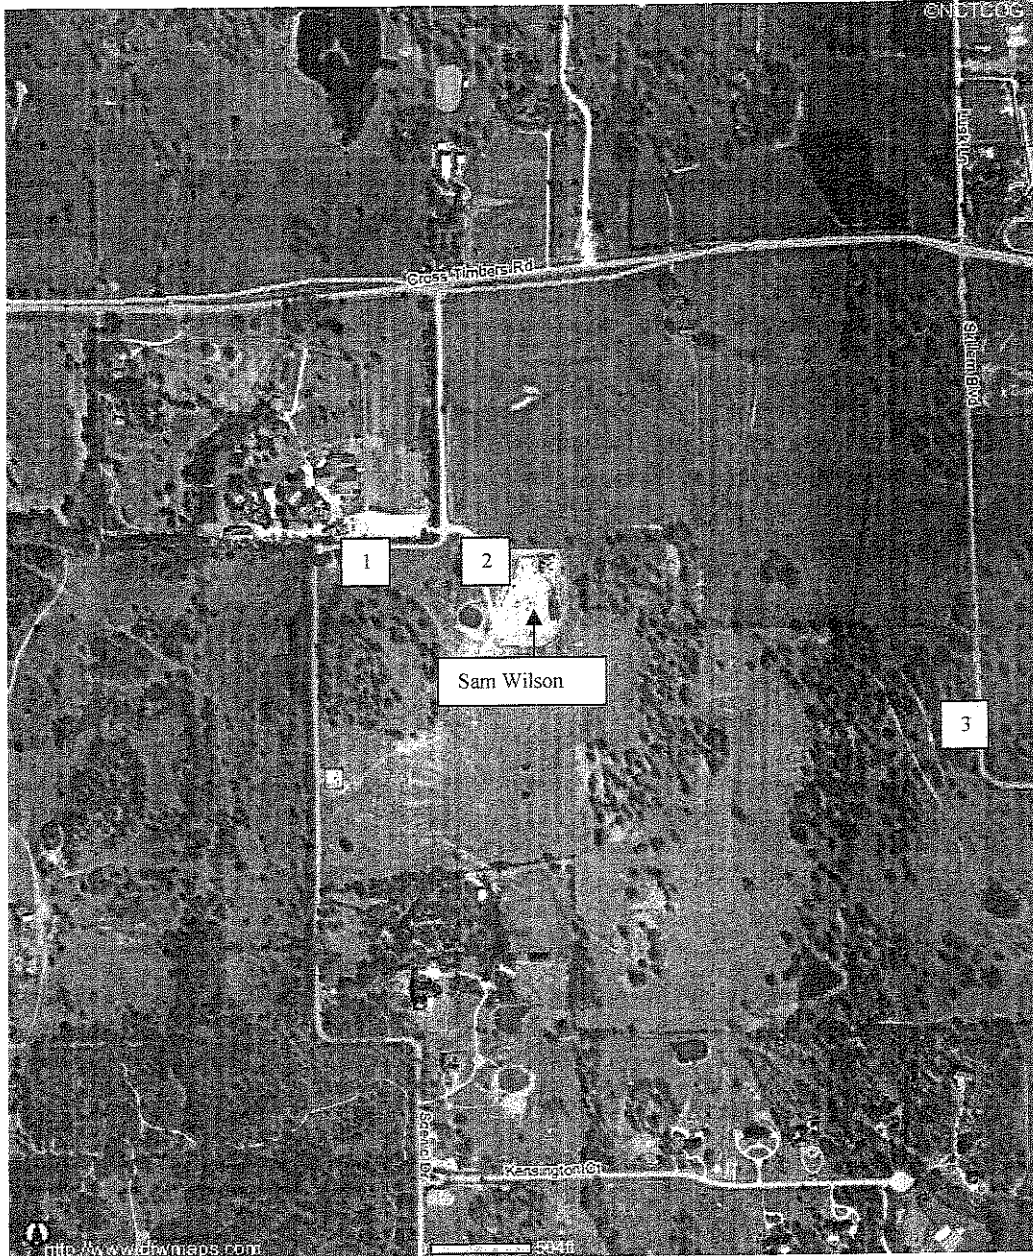
Survey Map

Odor Survey Route

Location 1 – At 8:15 AM, no odor was noted. MiniRae readings averaged 0.0 ppm.

Location 2 – No odor was noted. MiniRae readings averaged 0.0 ppm.

Location 3 – At 10:25 AM, no odor was noted. MiniRae readings averaged 0.0 ppm. A Summa canister air sample was taken at this location. Wind out of northwest at 3.2 mph.

On January 21, 2010, the investigators arrived at Williams - Sam Wilson at 8:15 AM. The investigators proceeded to Location 1 approximately 700 feet west of the facility on Scenic Drive (Attachment 1 for a Survey Map). Off-site observation at Location 1 with the GasFindIR camera did not reveal any emissions from the facility. The MiniRae readings averaged 0.0 parts per million (ppm) with a peak value of 0.0 ppm.

During the survey both upwind and downwind of the facility, no odors were noted on the survey route (Attachment 1 for a Survey Map).
